# Manhole Inspection Summary

Manhole # S21A1\_006MH

Insp Date: **6/5/08 10:26 AM**

**Location** Address: **2132 lind st**

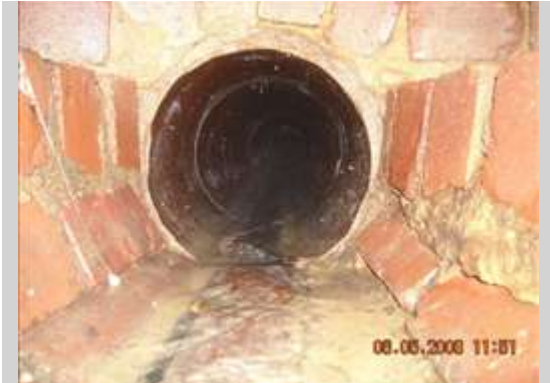
12 O'Clock Outflow

8 in. Circular Gravity Sewer  
Pipe Out @ 12 O'Clock

Pipe Height: **8.4** (in.) Rod and Bar (Angled)  
Pipe Material: **Clay** ☐ Pipe Lined  
Invert Depth: **7.10** (ft.) Flow Characteristics: **Slow**  
Deposits: ☒ None ☐ Mud ☐ Sludge ☐ Debris ☐ Grease  
Silt Depth: **0** (in.) Deposits Extent:  
Infiltration: **None** Pipe Seal Cond: **Sound**

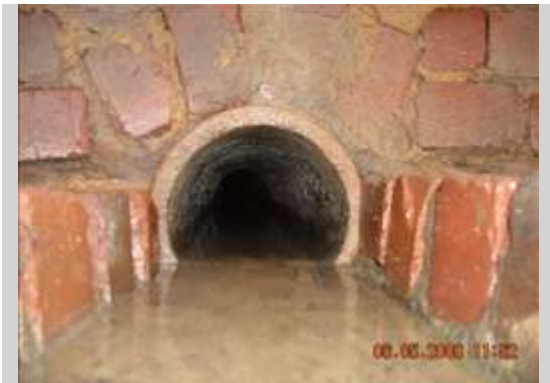
4 O'Clock Inflow

6 in. Circular Gravity Sewer  
Pipe In @ 5 O'Clock

Pipe Height: **6** (in.) Rod and Bar (Angled)  
Pipe Material: **Clay** ☐ Pipe Lined  
Invert Depth: **6.88** (ft.) Flow Characteristics: **Slow**  
Deposits: ☒ None ☐ Mud ☐ Sludge ☐ Debris ☐ Grease  
Silt Depth: **0** (in.) Deposits Extent:  
Infiltration: **None** Pipe Seal Cond: **Sound**

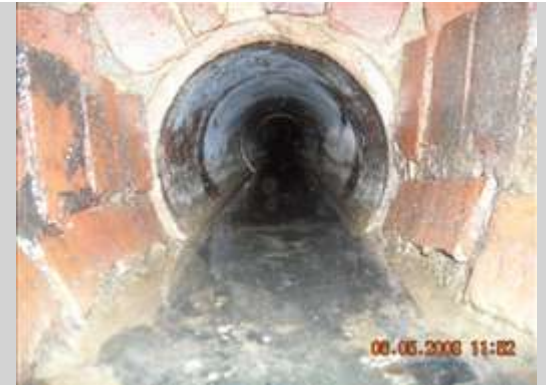
9 O'Clock Inflow

8 in. Circular Gravity Sewer

Pipe In @ 9 O'Clock

Pipe Height: **8.4** (in.) Rod and Bar (Angled)
